Subject: FW: [VRPGemsof94] Fact behind Building Collapse In Shanghai (China)

## **LESSONS LEARNED**

### **Building Collapsed In Shanghai (06/27/2009) (Daqi)**

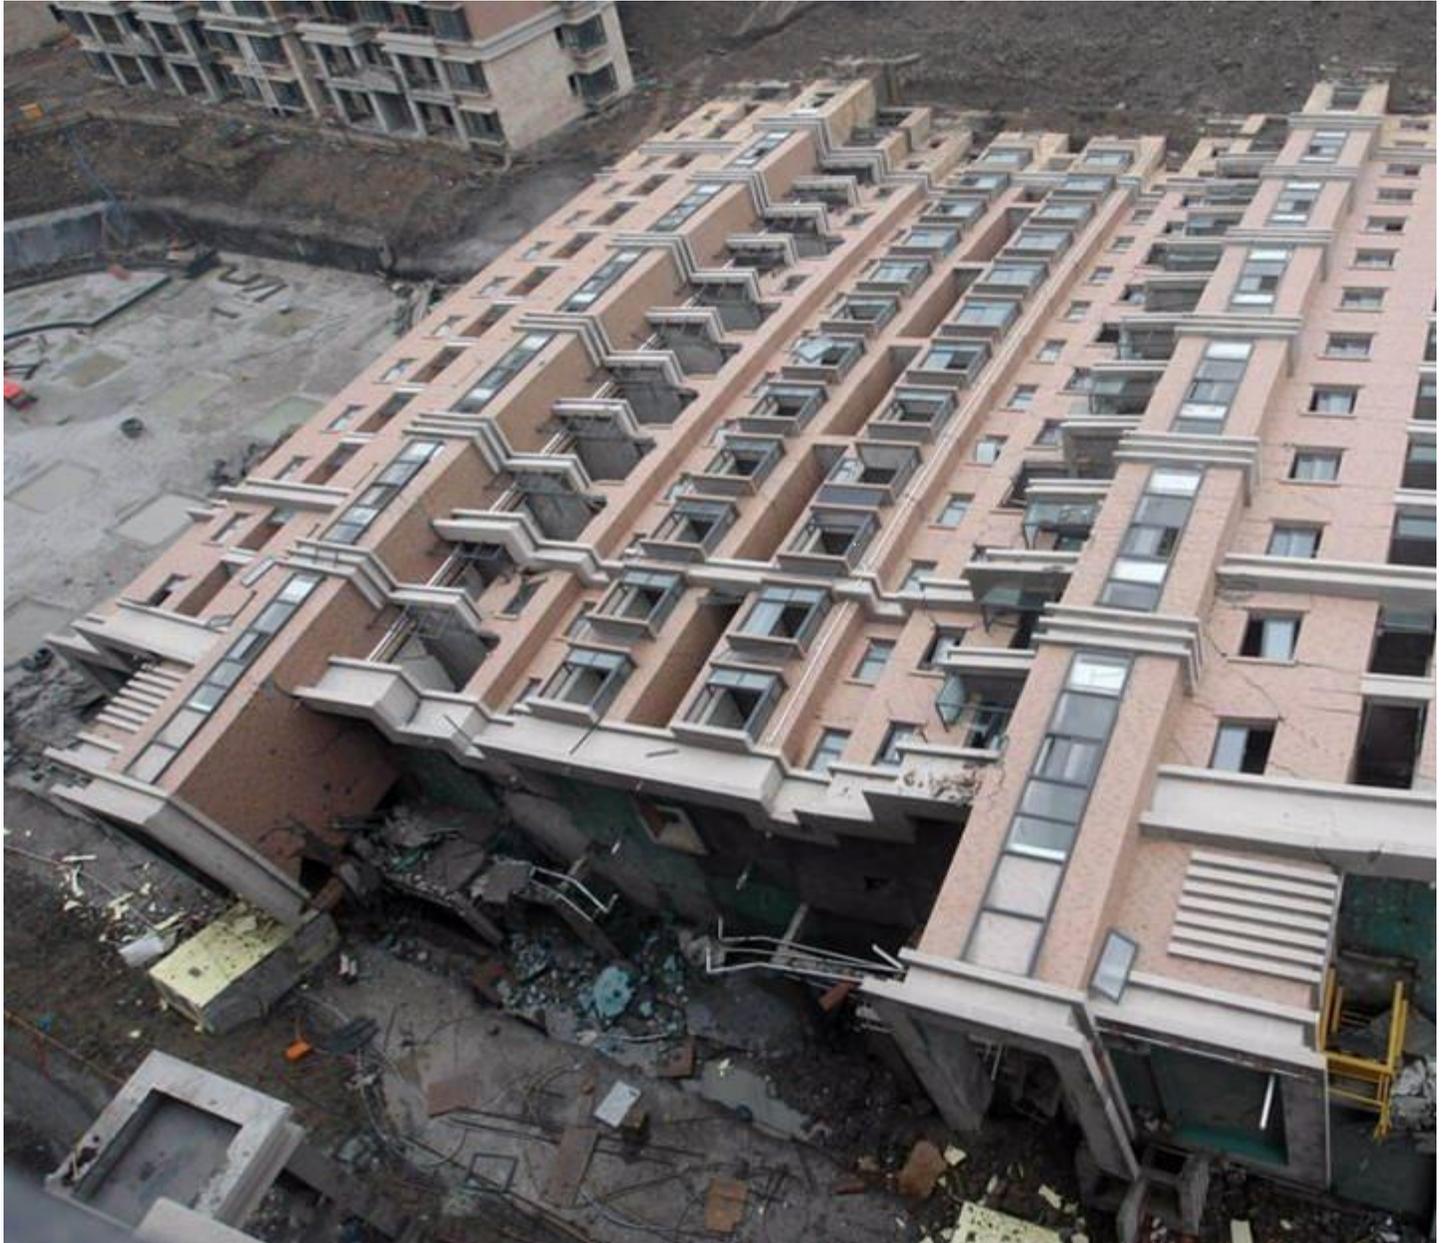
At around 5:30am on June 27, an unoccupied building still under construction at Lianhuan Road in the Minhang district of Shanghai city toppled over. One worker was killed. According to information, a 70 meter section of the flood prevention wall in nearby Dianpu River and that may have something to do with this building collapse.

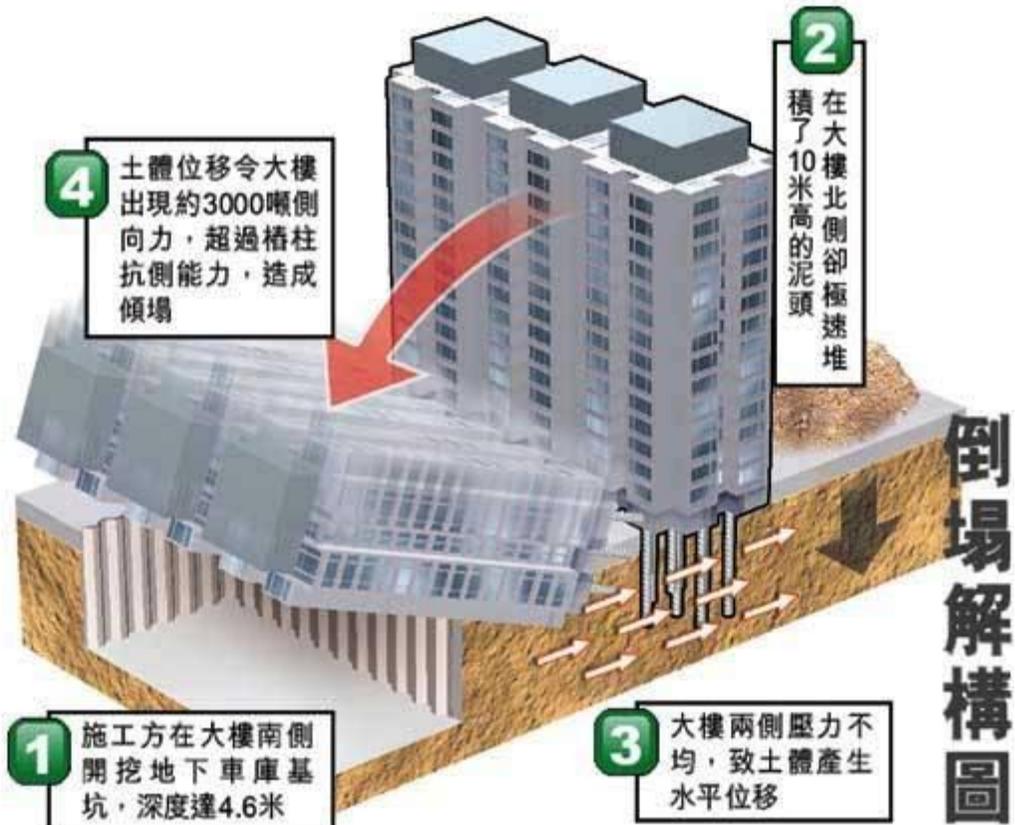
- (1) An underground garage was being dug on the south side, to a depth of 4.6 meters
- (2) The excavated dirt was being piled up on the north side, to a height of 10 meters
- (3) The building experienced uneven lateral pressure from south and north
- (4) This resulted in a lateral pressure of 3,000 tons, which was greater than why the pilings could tolerate. Thus the building toppled over in the southerly direction.

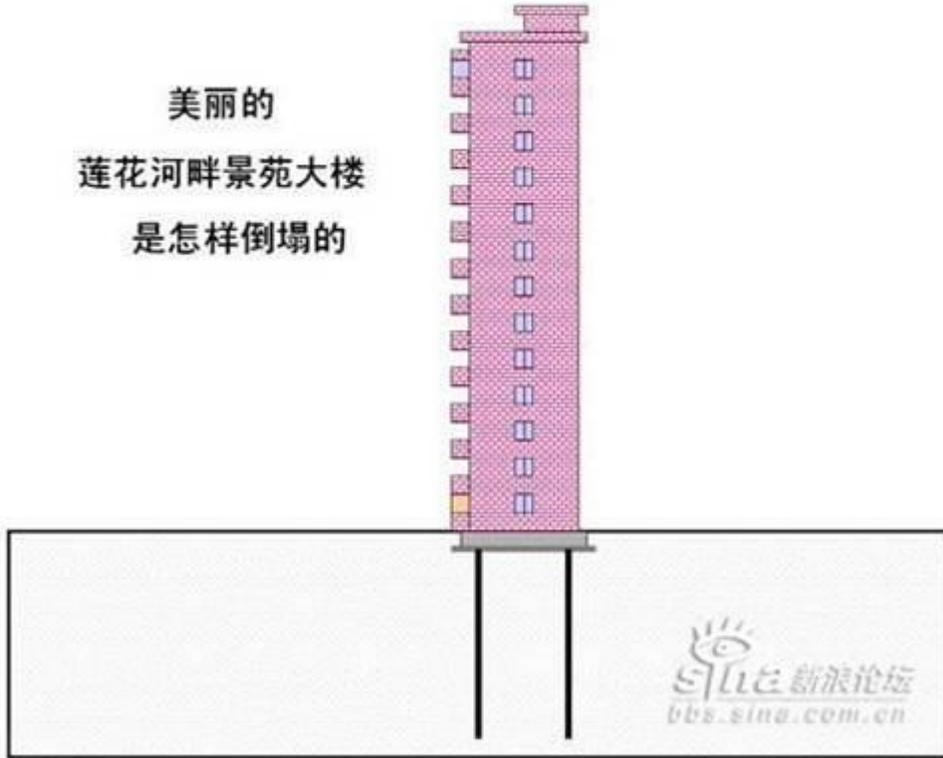
First, the apartment building was constructed

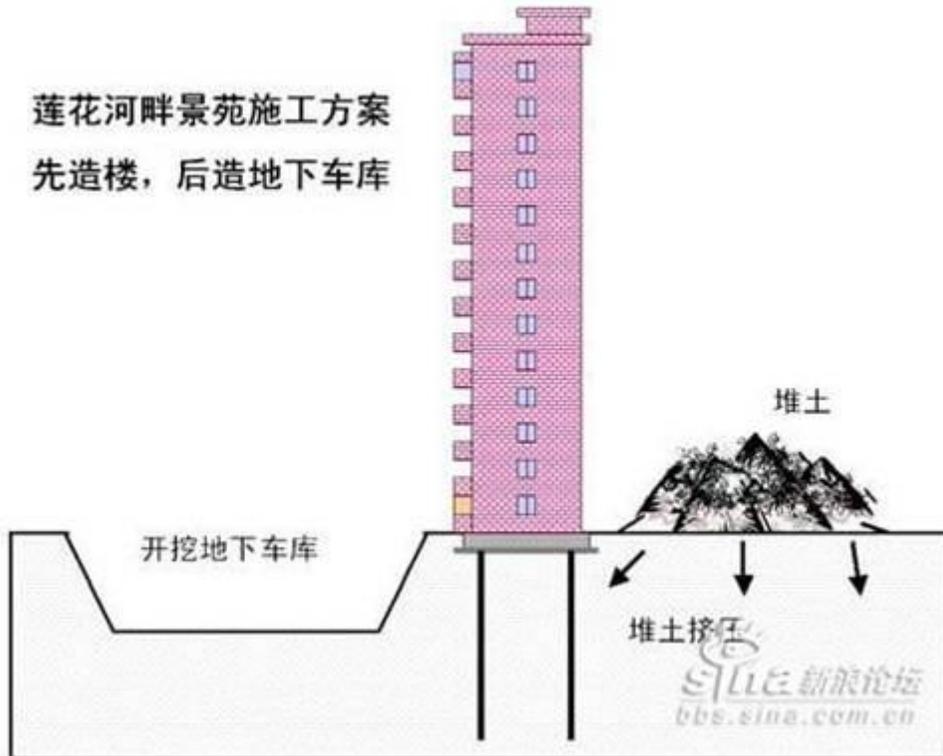
Then the plan called for an underground garage to be dug out.  
The excavated soil was piled up on the other side of the building.

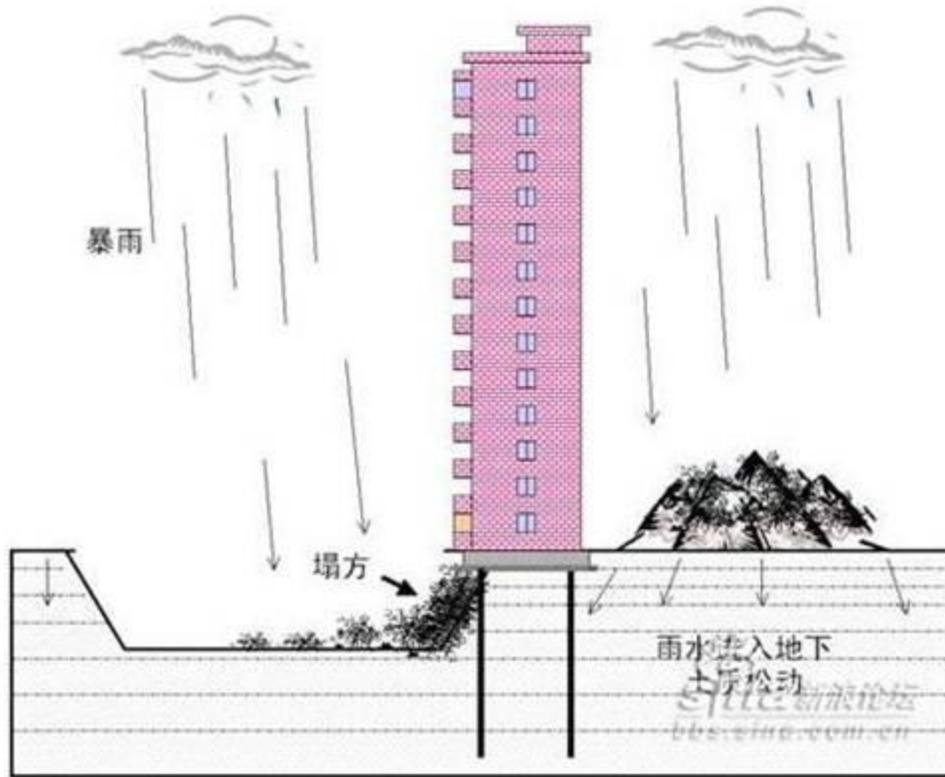
Heavy rains resulted in water seeping into the ground.

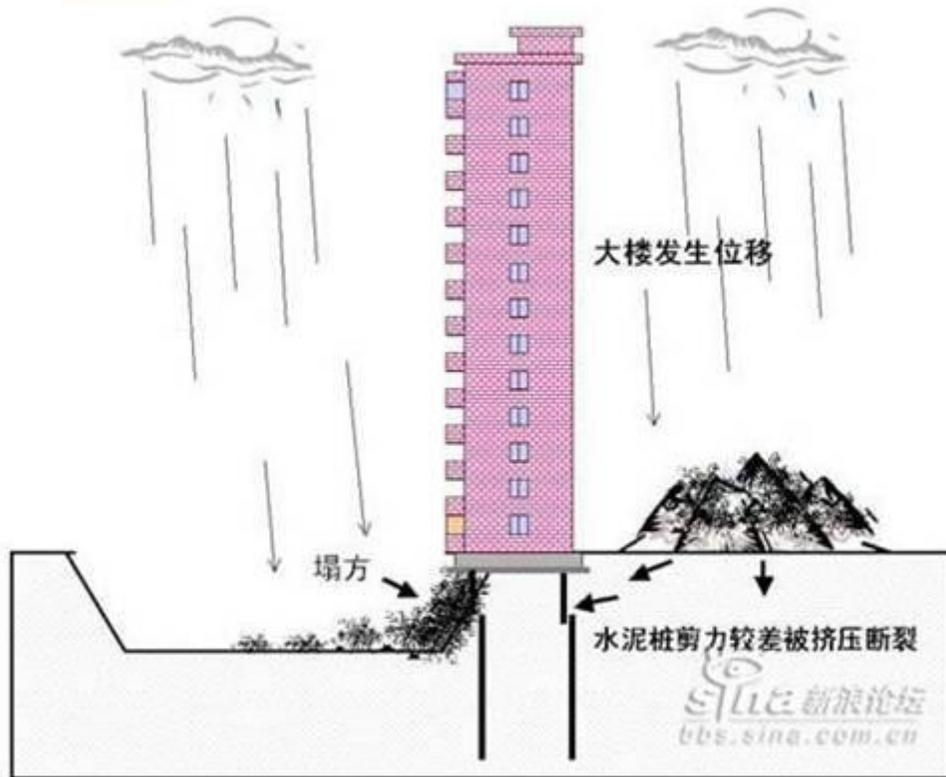
The building began to shift and the concrete pilings were snapped due to the uneven lateral pressures.

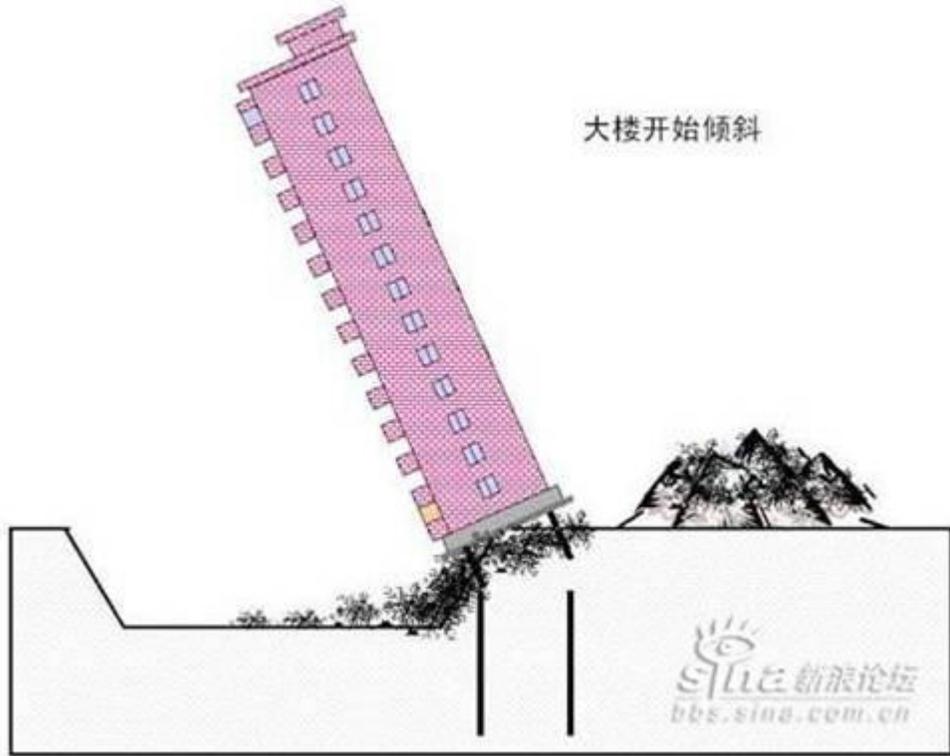
The building began to tilt.
