Subject: FW: [VRPGemsof94] Fact behind Building Collapse In Shanghai (China)

## **LESSONS LEARNED**

### **Building Collapsed In Shanghai (06/27/2009) (Daqi)**

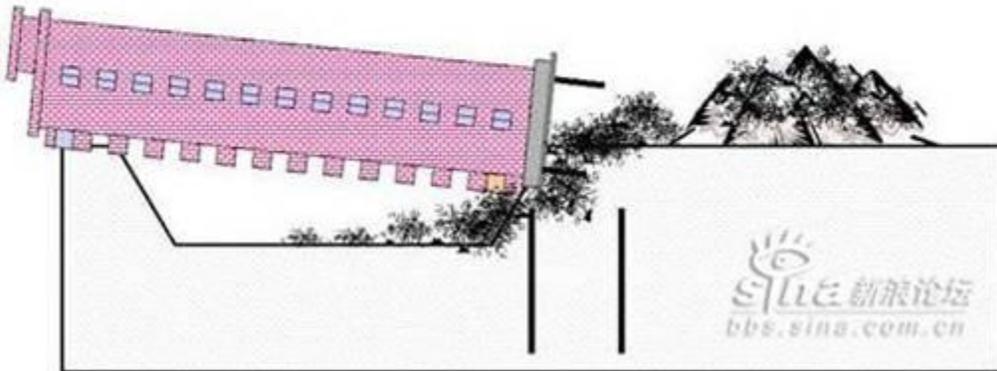
The building began to tilt.

创造世界房屋倒塌奇迹

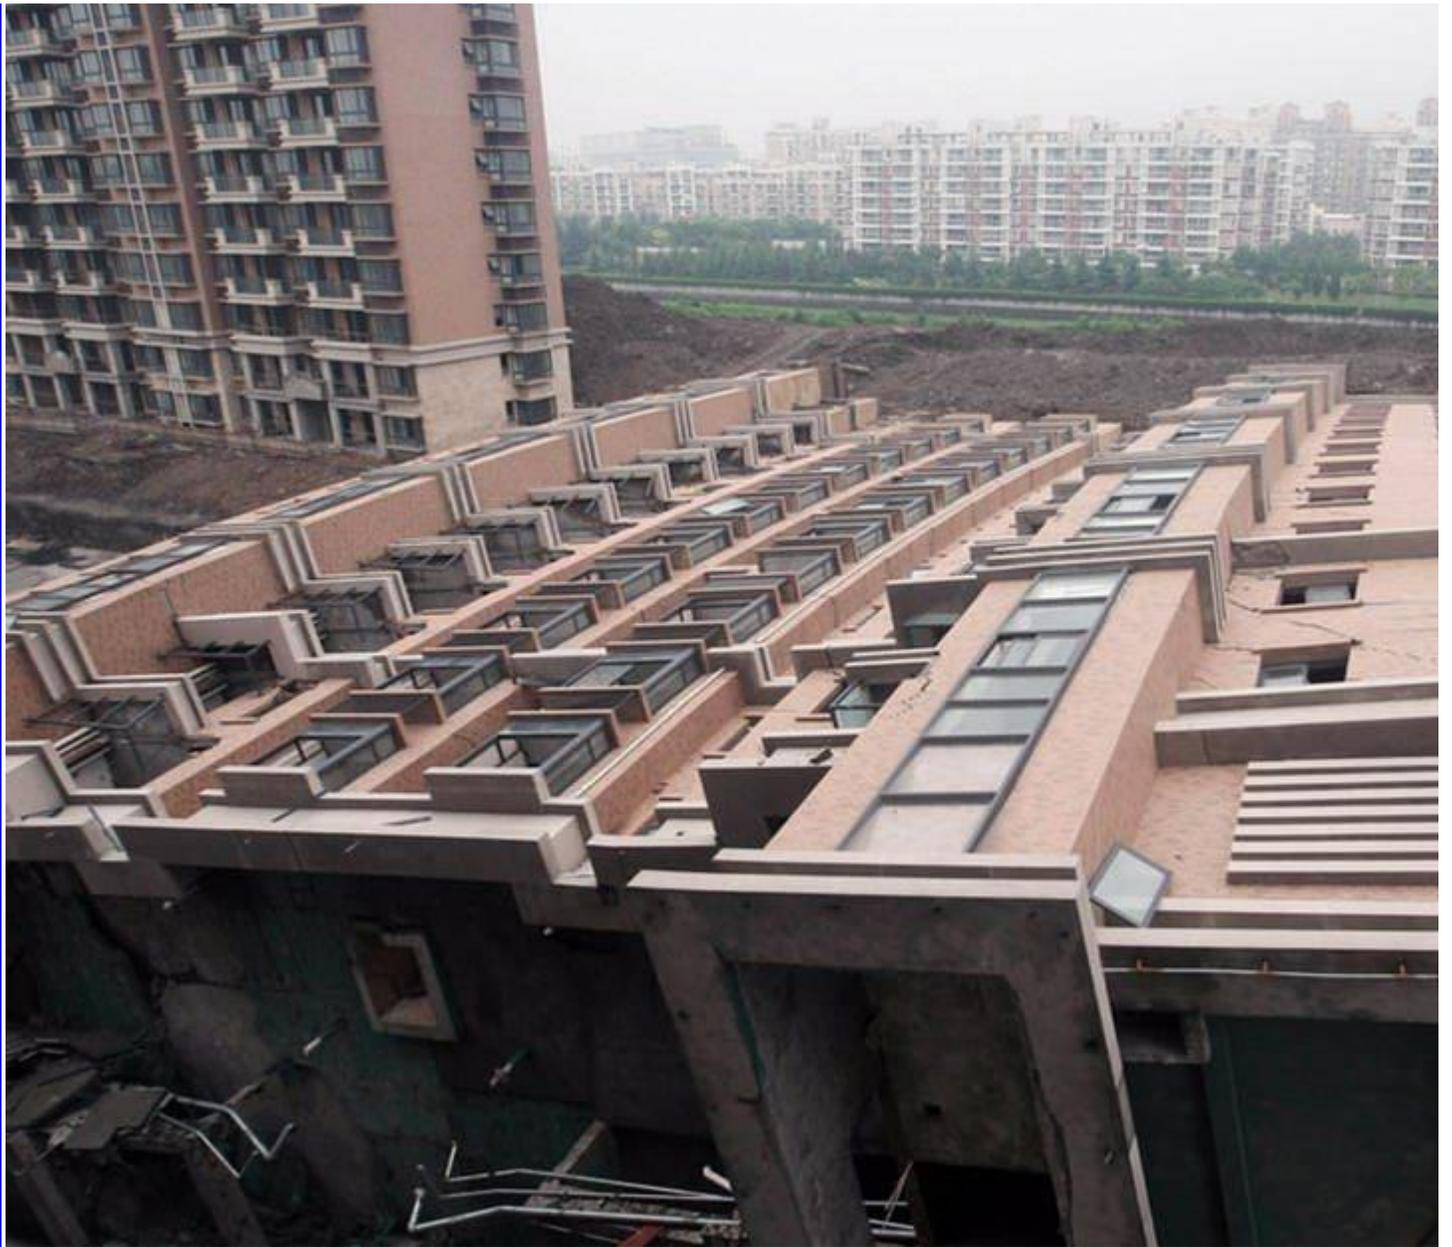
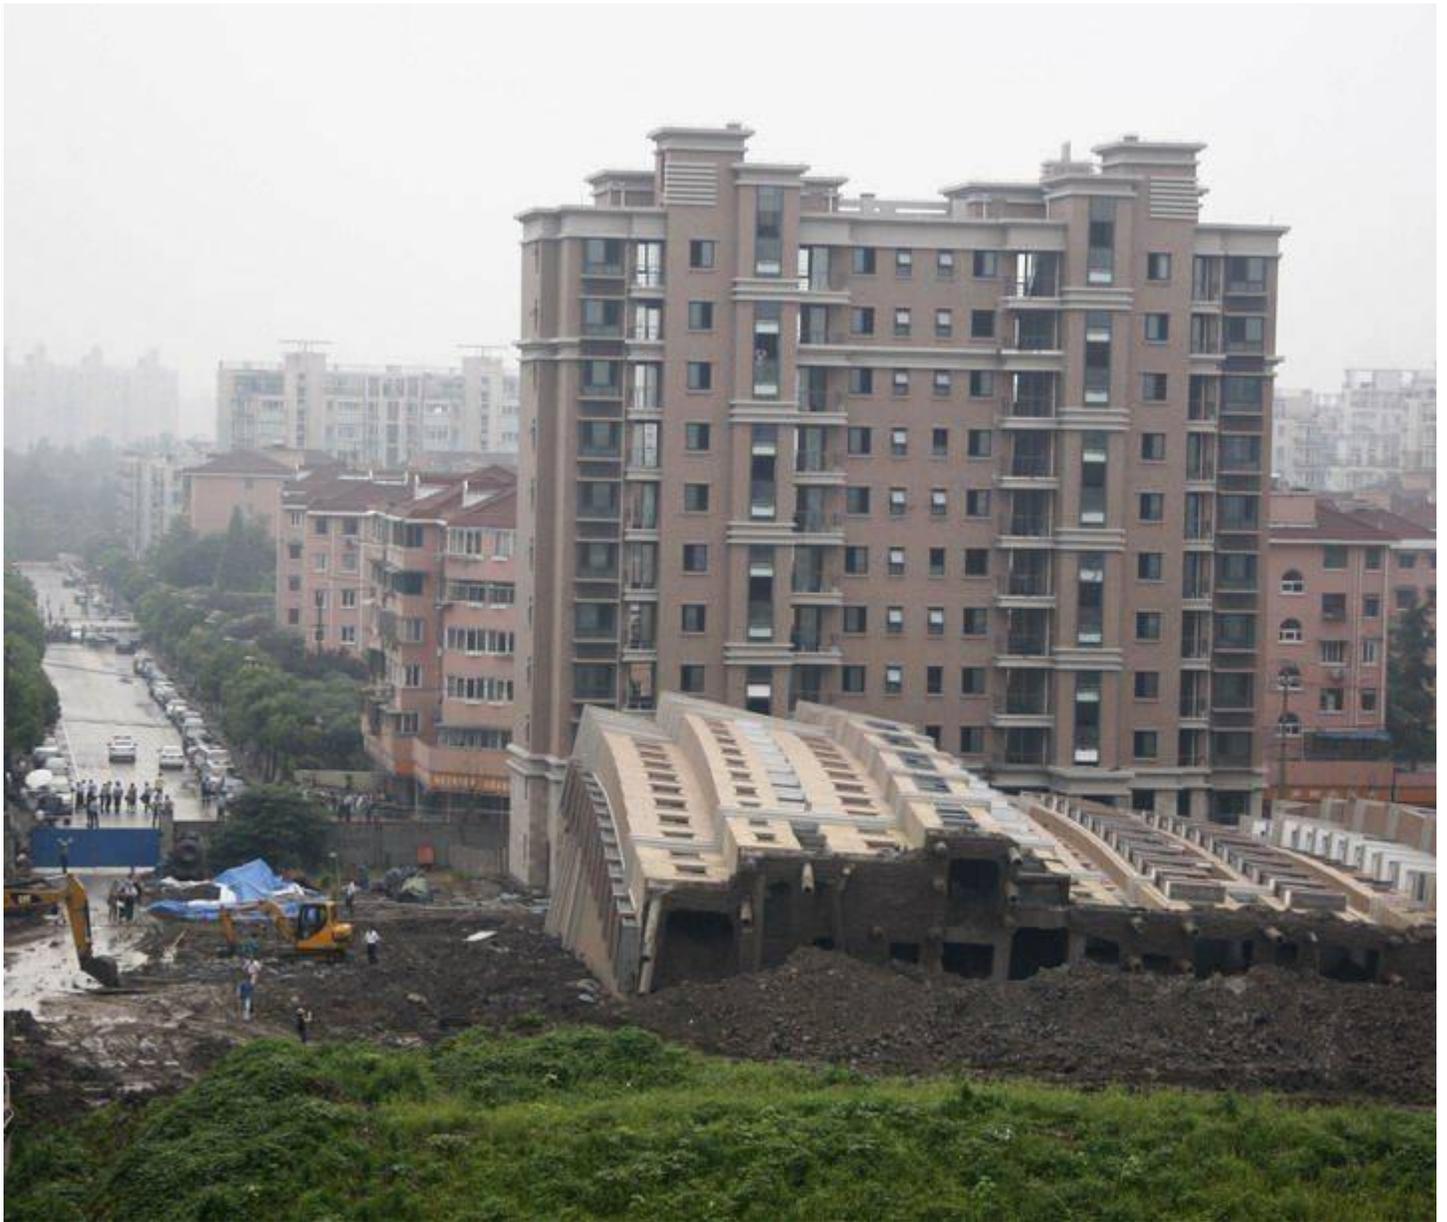
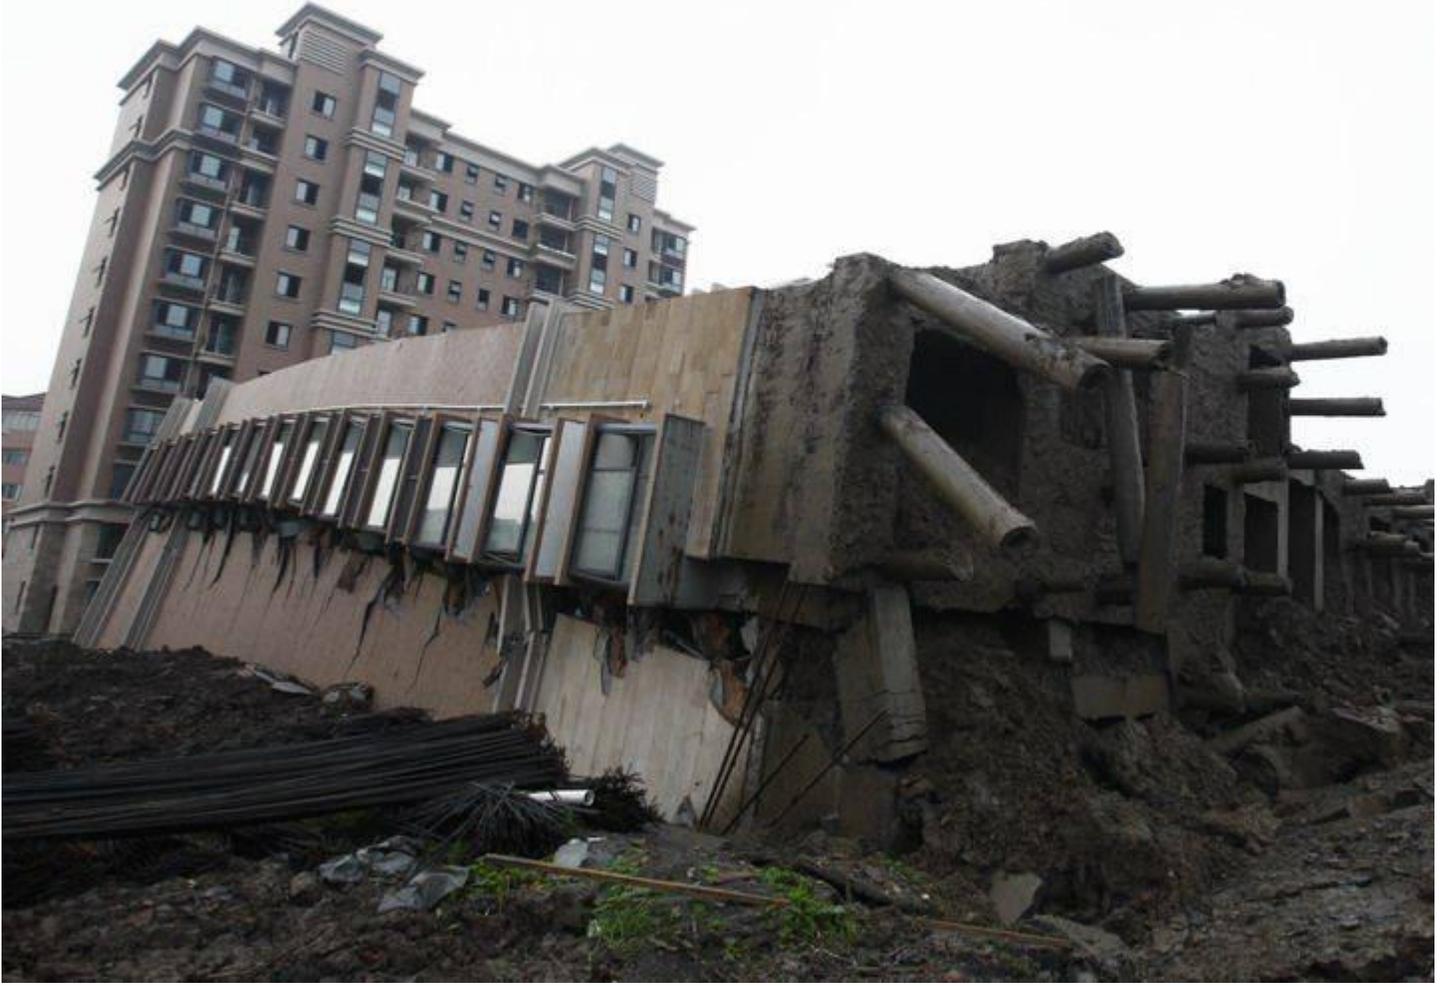
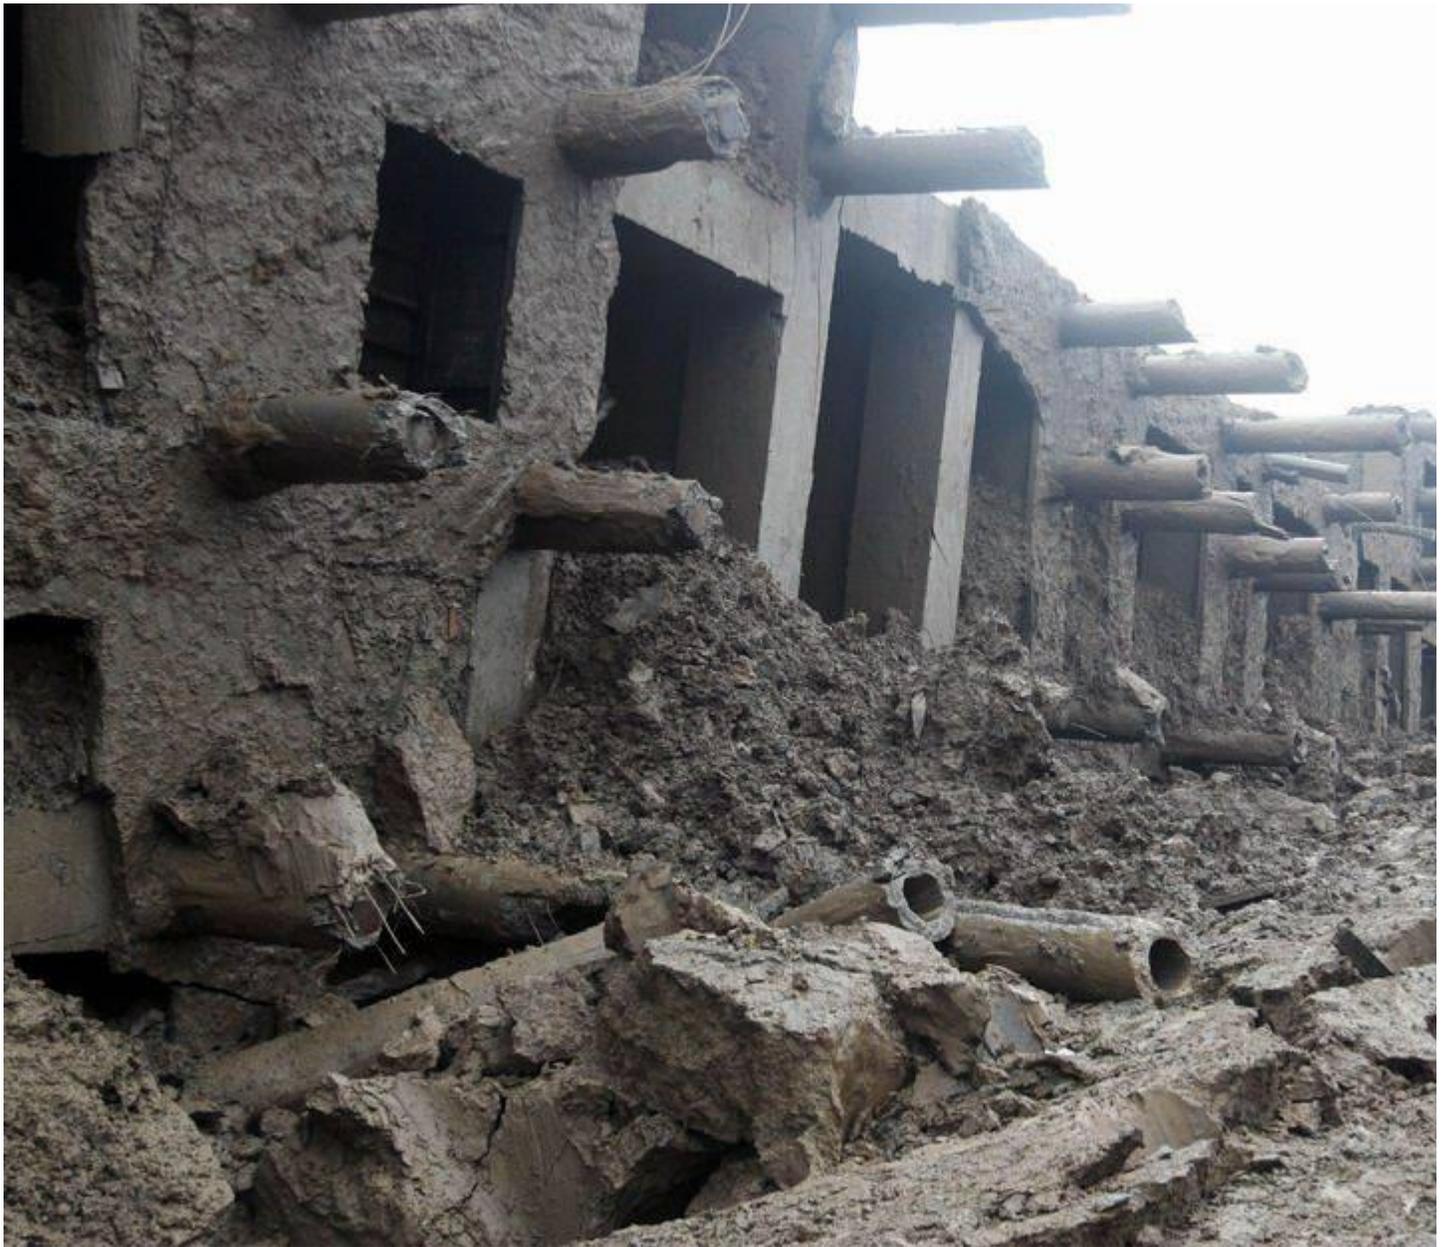
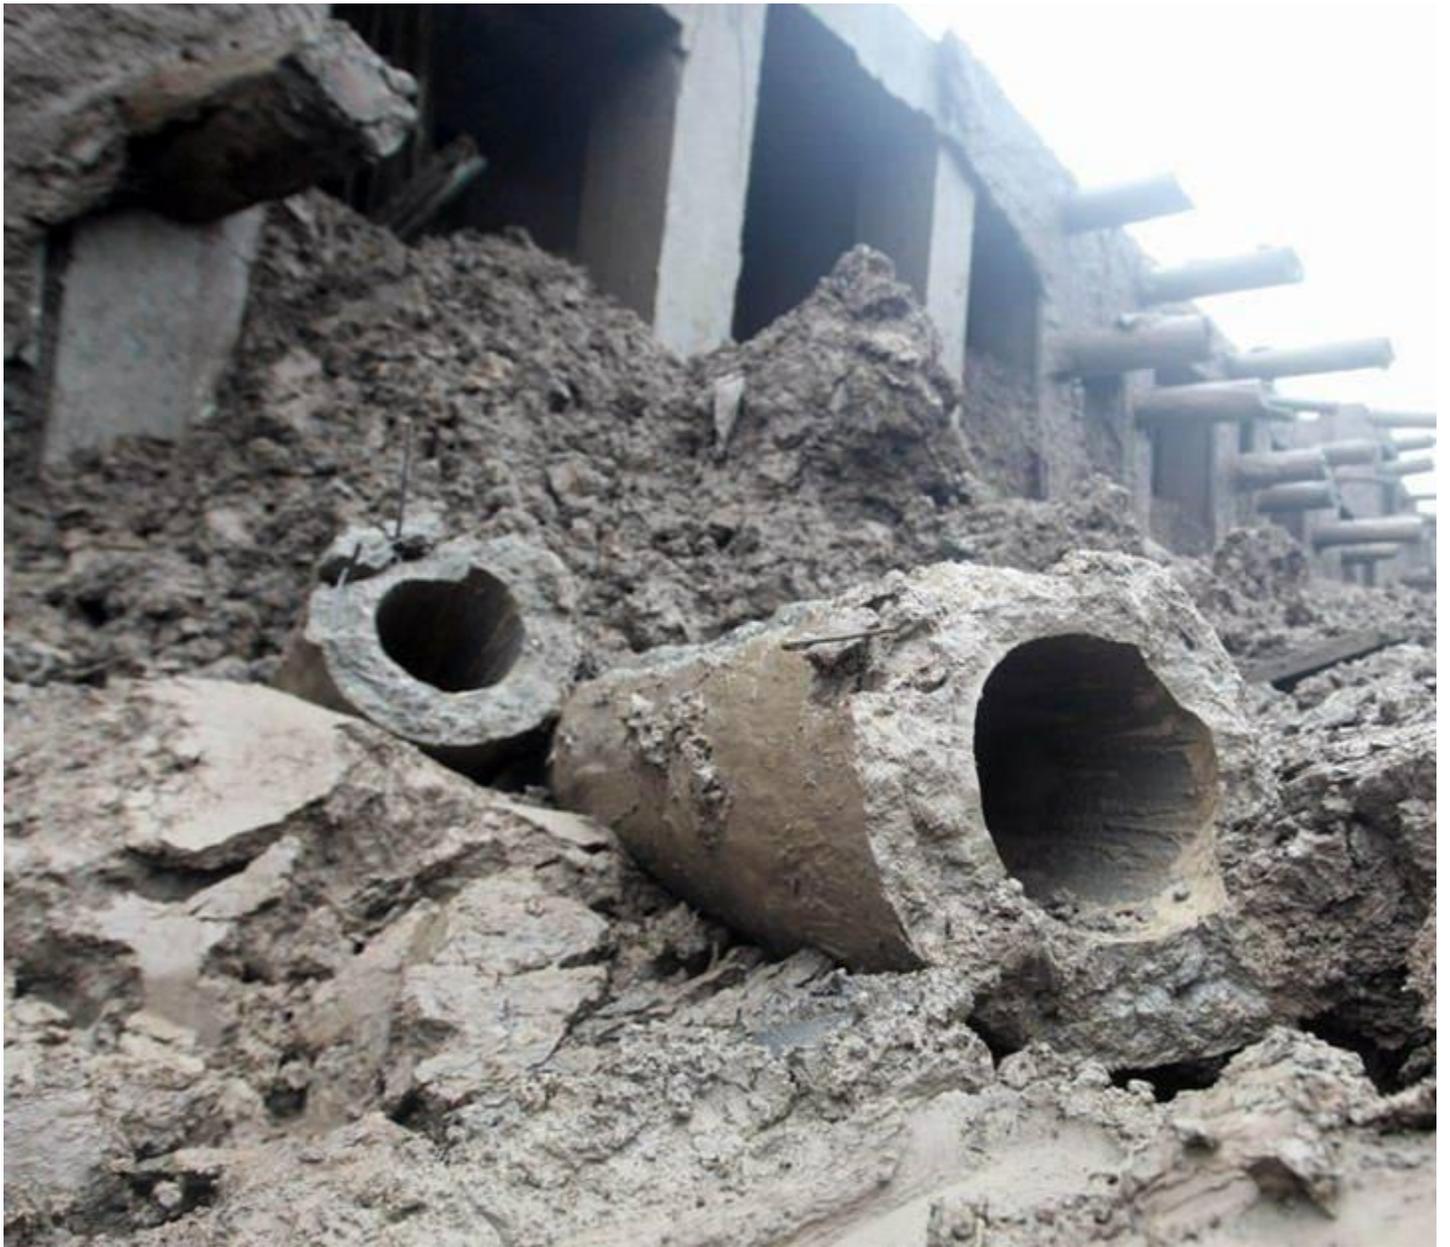
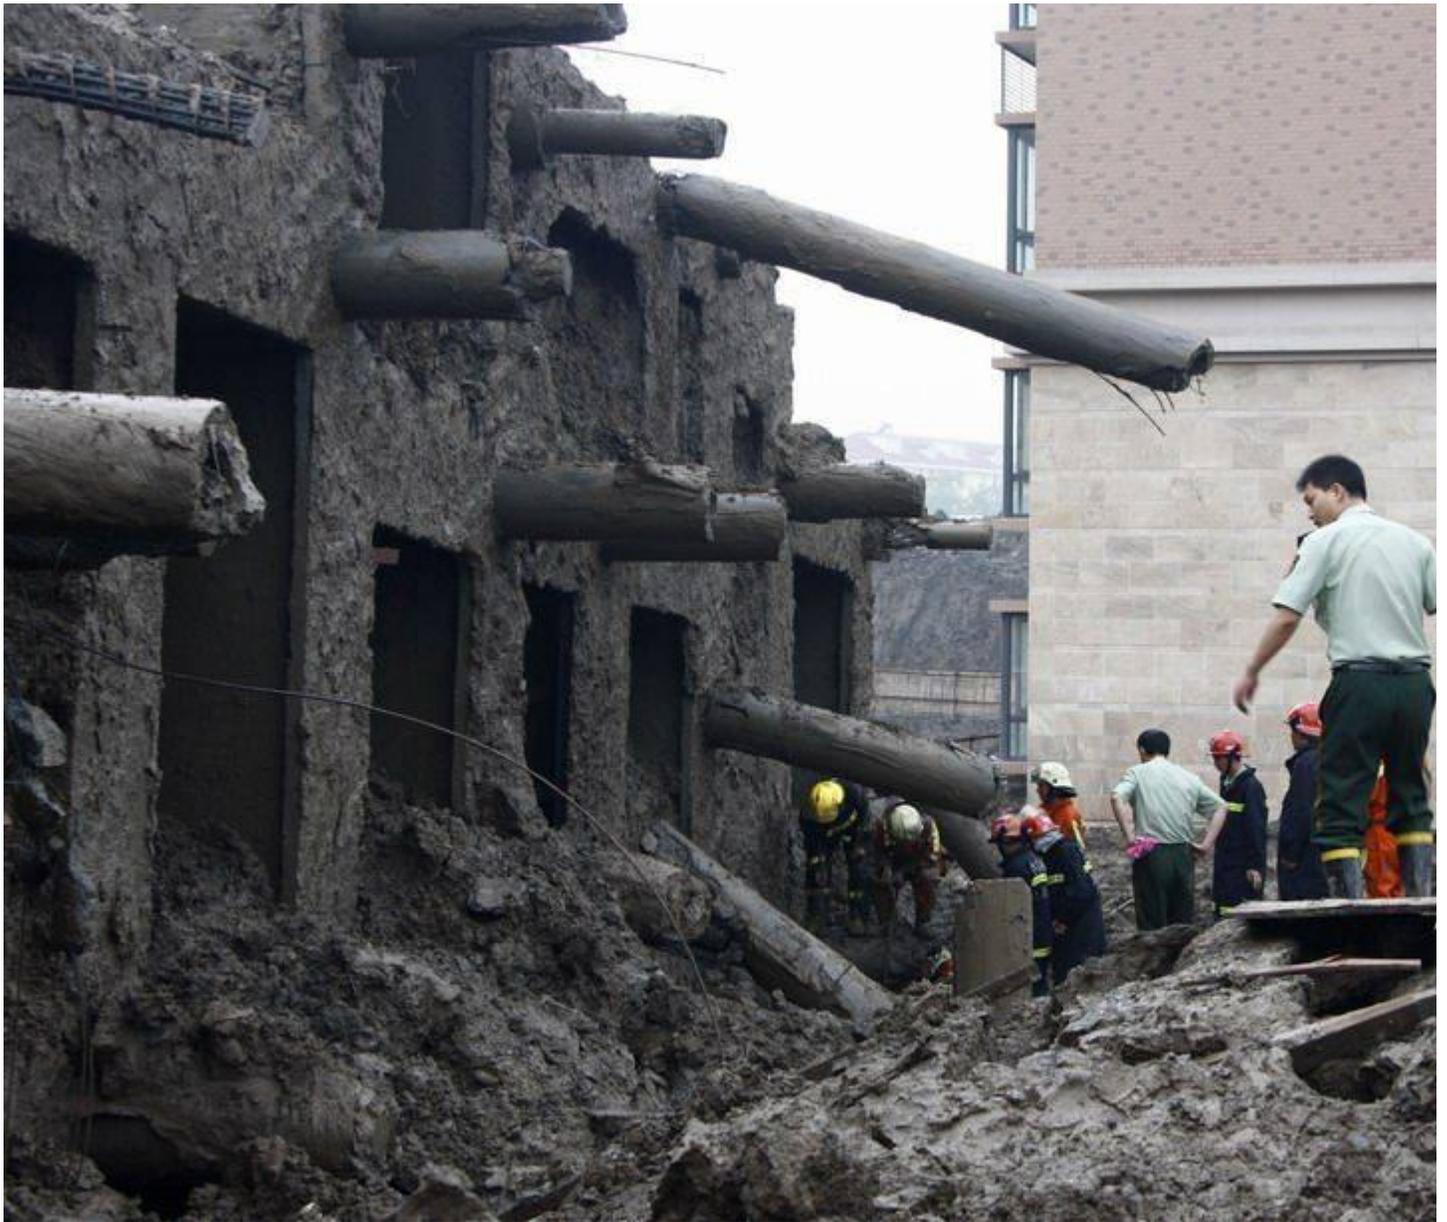
The report said the collapse was caused by earth, excavated to make a 4.6-metre deep pit for an underground car park alongside the building, being piled to depths of up to 10 metres on the other side of the structure. The weight of the pile created a "pressure differential" which led to a shift in the soil structure, eventually weakening the foundations and causing them to fail. This situation "may" have been aggravated by several days of heavy rain leading up to the collapse, but investigators would not say whether this was a crucial factor. The report said the construction company - Shanghai Zhongxin Construction - "did not consider clearly" that the earth pile could have such a devastating effect.

And thus came the eighth wonder of the world.
